## CSX Railway Needs More Track Space

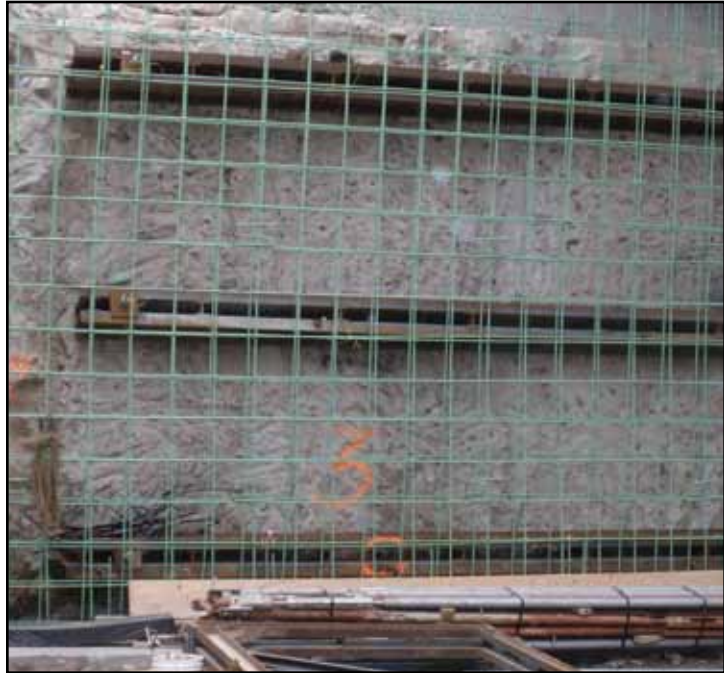
*The contractor removed an existing retaining wall to widen access to the rail yard.*

CSX Transportation asked their contractor for ideas, and the proposal included removing an existing retaining wall on the south edge of the viaduct and pouring a new wall approximately 20' further into the embankment to widen the access to the rail yard.

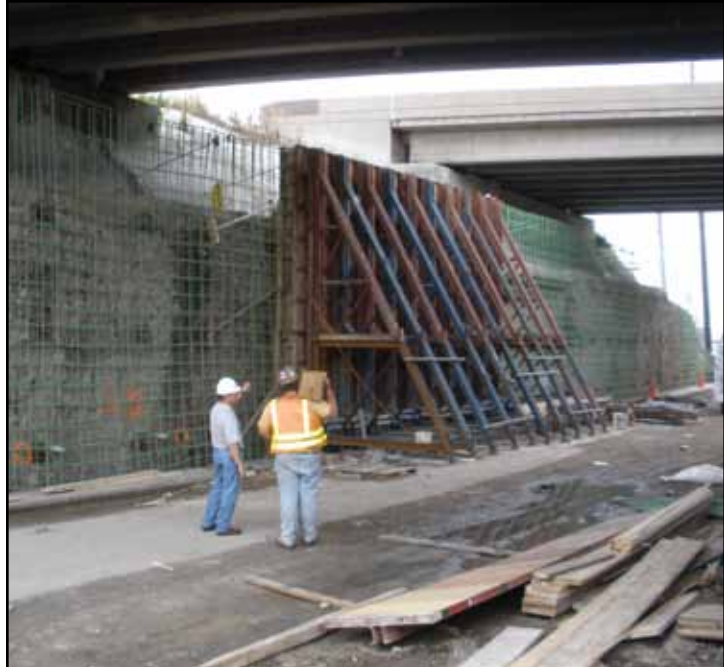
*The Backbone frame braced a Steel-Ply gang for this one-sided forming application.*

The contractor had utilized various Symons forming systems for building median structures and sign pedestals for D.O.T. work, but they had never constructed a wall of this size under these conditions. After contacting Symons, they chose to use the Steel-Ply forming system combined with the Backbone™ one-sided forming frame for this project.

larities common with cast-in Tie Rods. It was also suggested that they utilize 9' Steel-Ply panels in a horizontal gang to easily accommodate the Backbone frames at 3' centers.

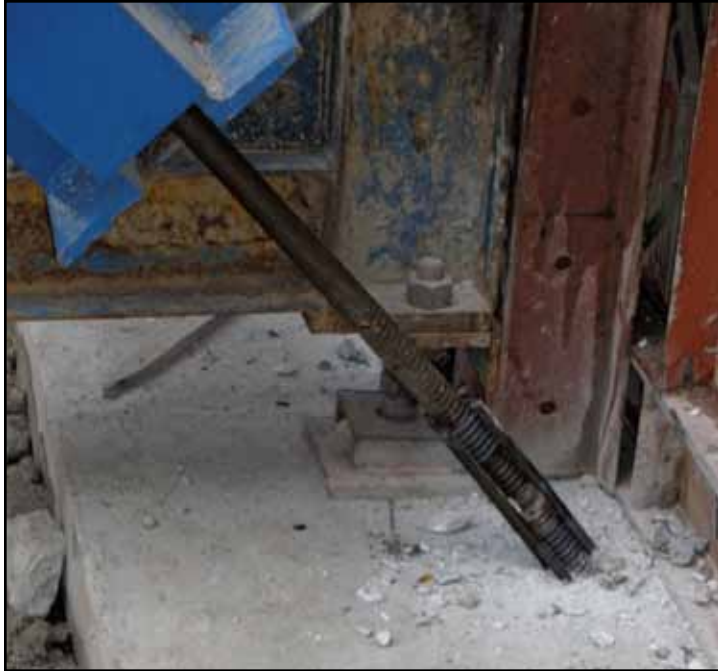
*Coil Rod was epoxied into the footings after the frames were in place, so there was never any problem with the Tie Rods.*

Symons contributed several ideas to help get the project moving along smoothly. One suggestion was that they pour the footing for the wall without positioning and casting in the Tie Rods. Instead, Coil Rod could be epoxied into the exact locations necessary, avoiding placement irregu-

After the 20' gang forms were placed and the frames attached and plumbed, the contractor drilled holes for 1¼" Coil Rod to be epoxied into the footing. 8" Coil Ties were utilized for the couplers and a Taper Tie for the Tie Rods that would be secured to the 8" walers. It went together perfectly, and they were ready to pour.

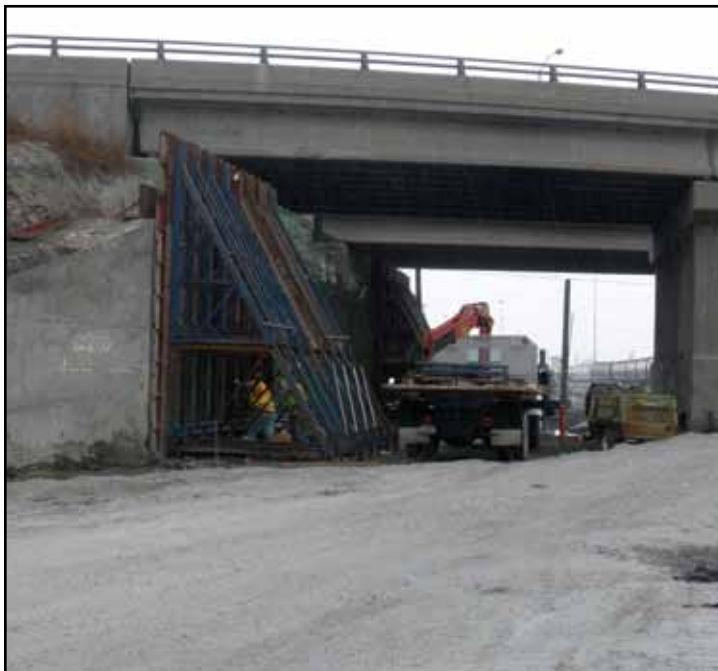
*When the new retaining wall was in place, CSX Railway gained the rail yard access that they required.*

After the first pour, they knew what to expect and prepared for the rest. They secured the footing and placed the rebar at the outside jacks prior to the next pour. They were able to set the first 60' of forms and frames up in about five days and were able to pour the next four sections and complete the 300' retaining wall within fifteen days.
